Jed River Catchment

Water information summary and interpretation

February 2023

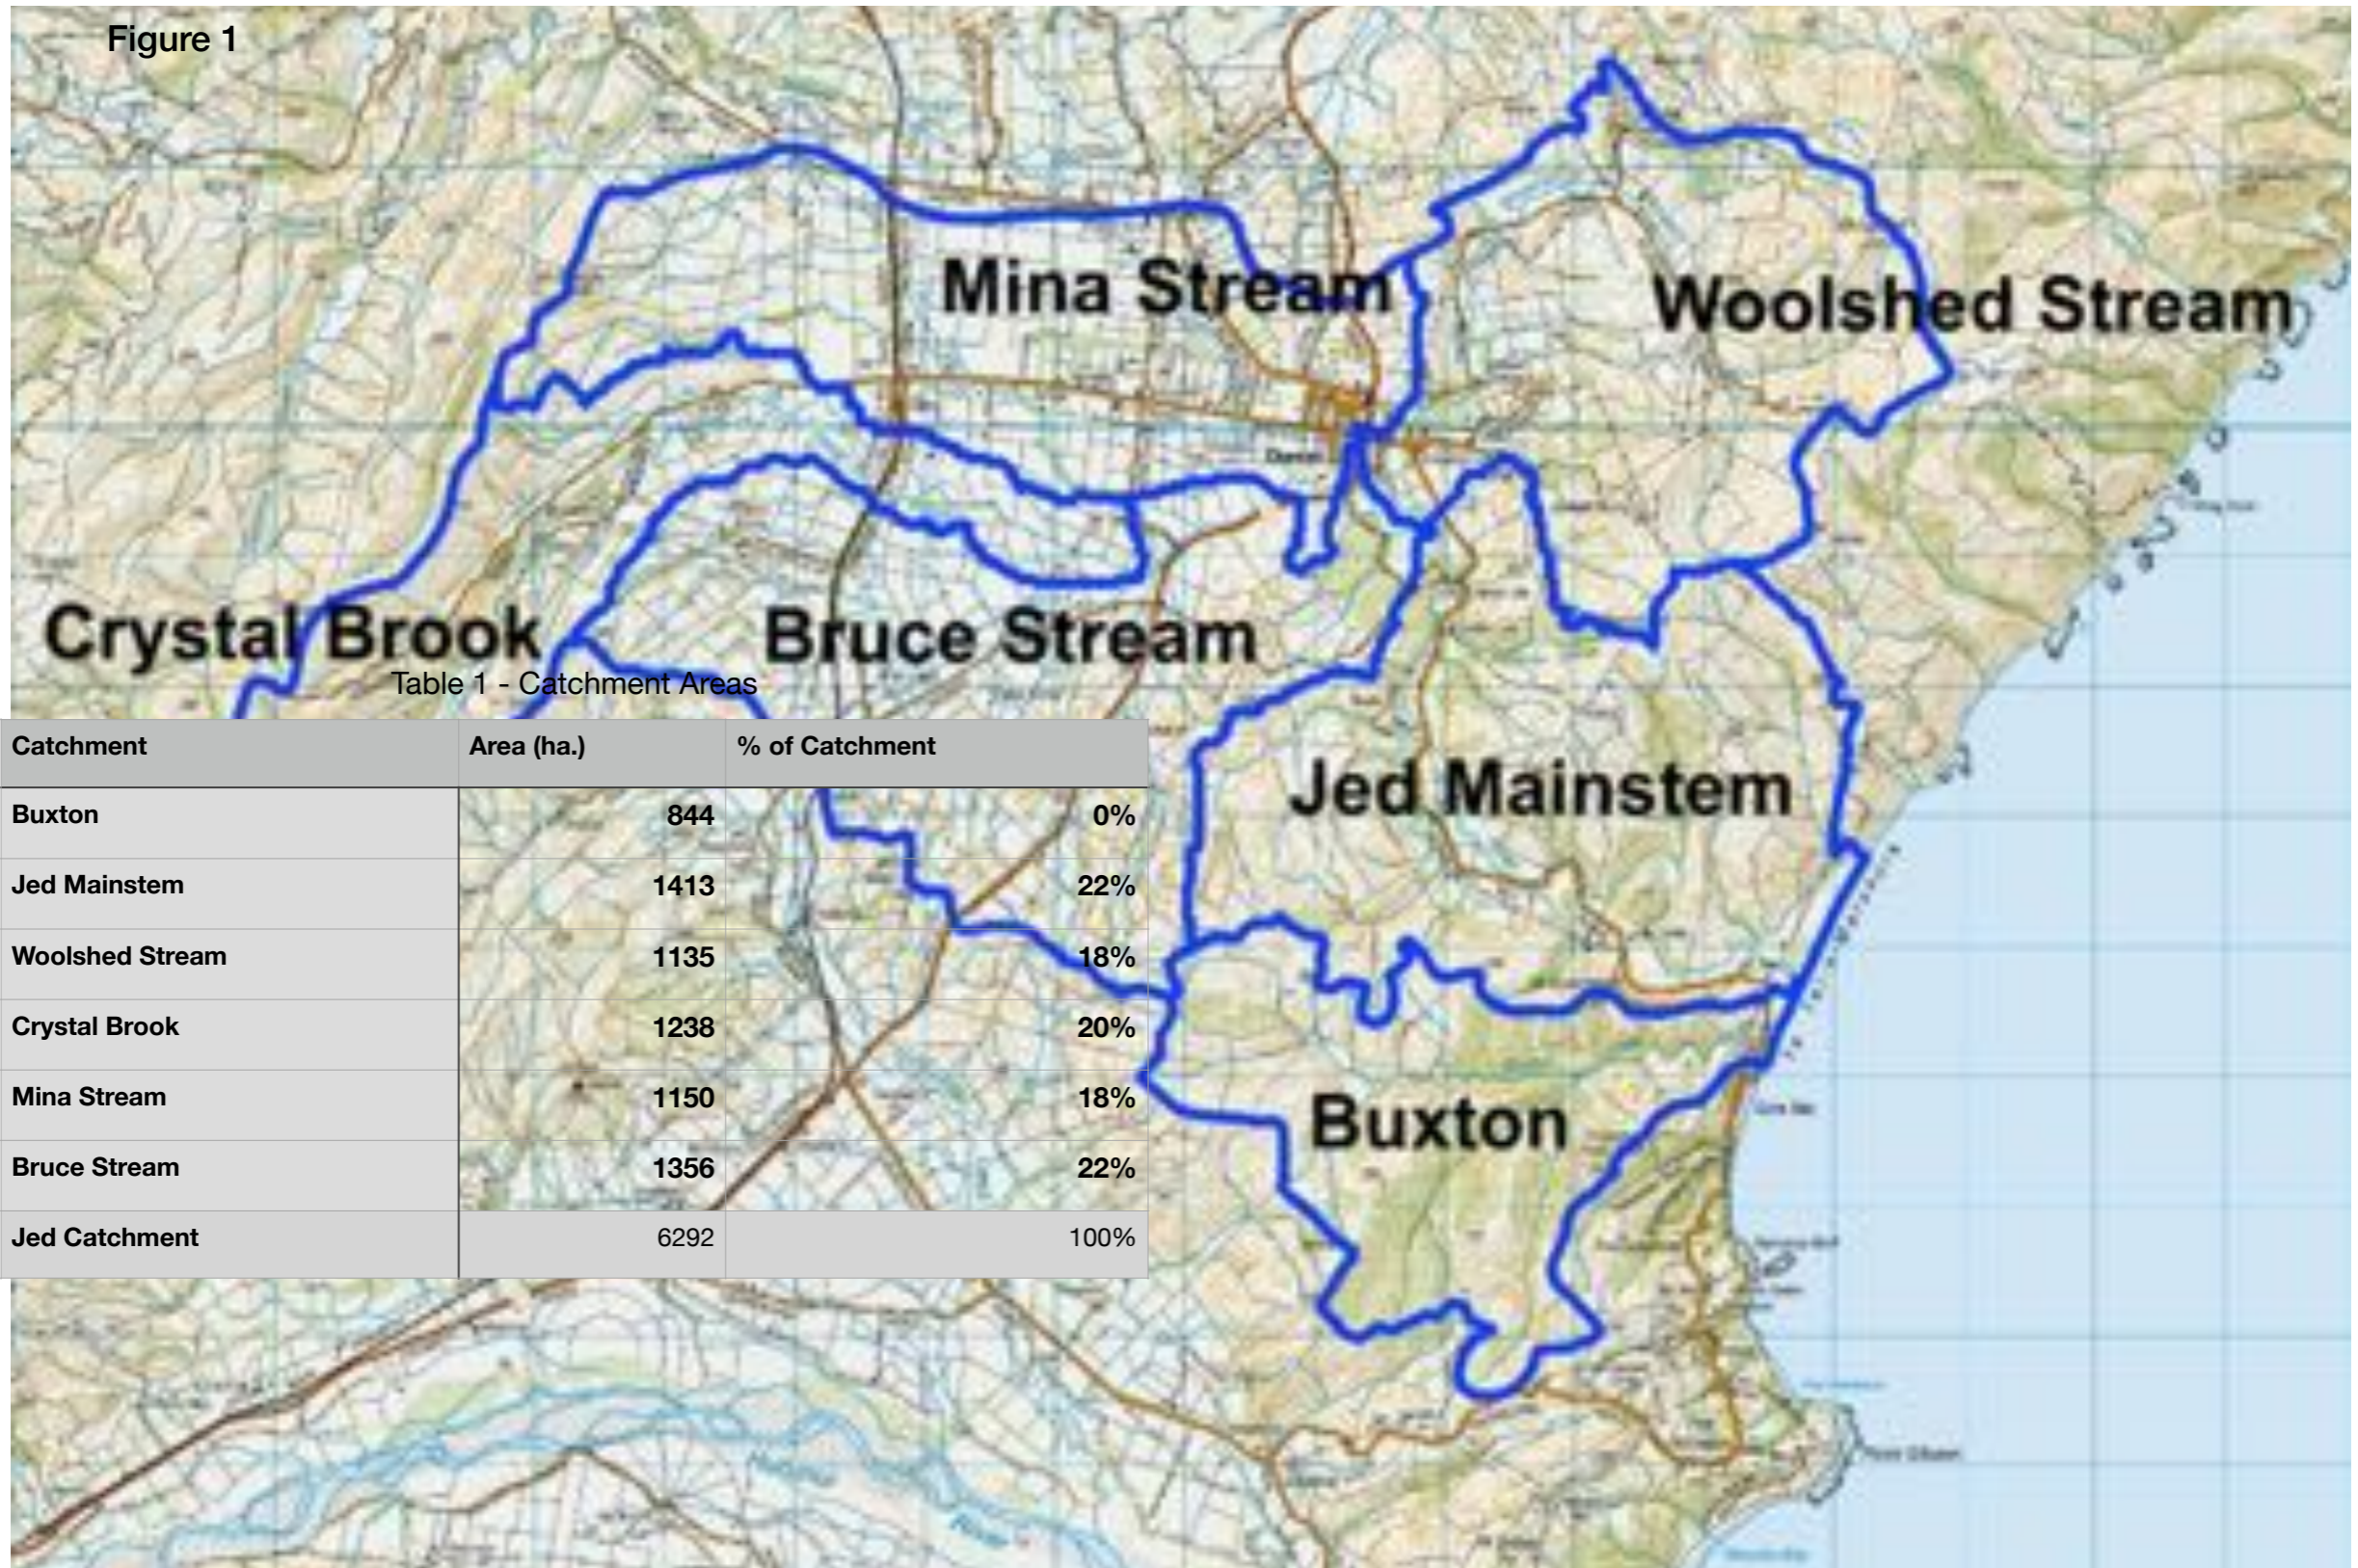
Figure 1

Jed River Catchment

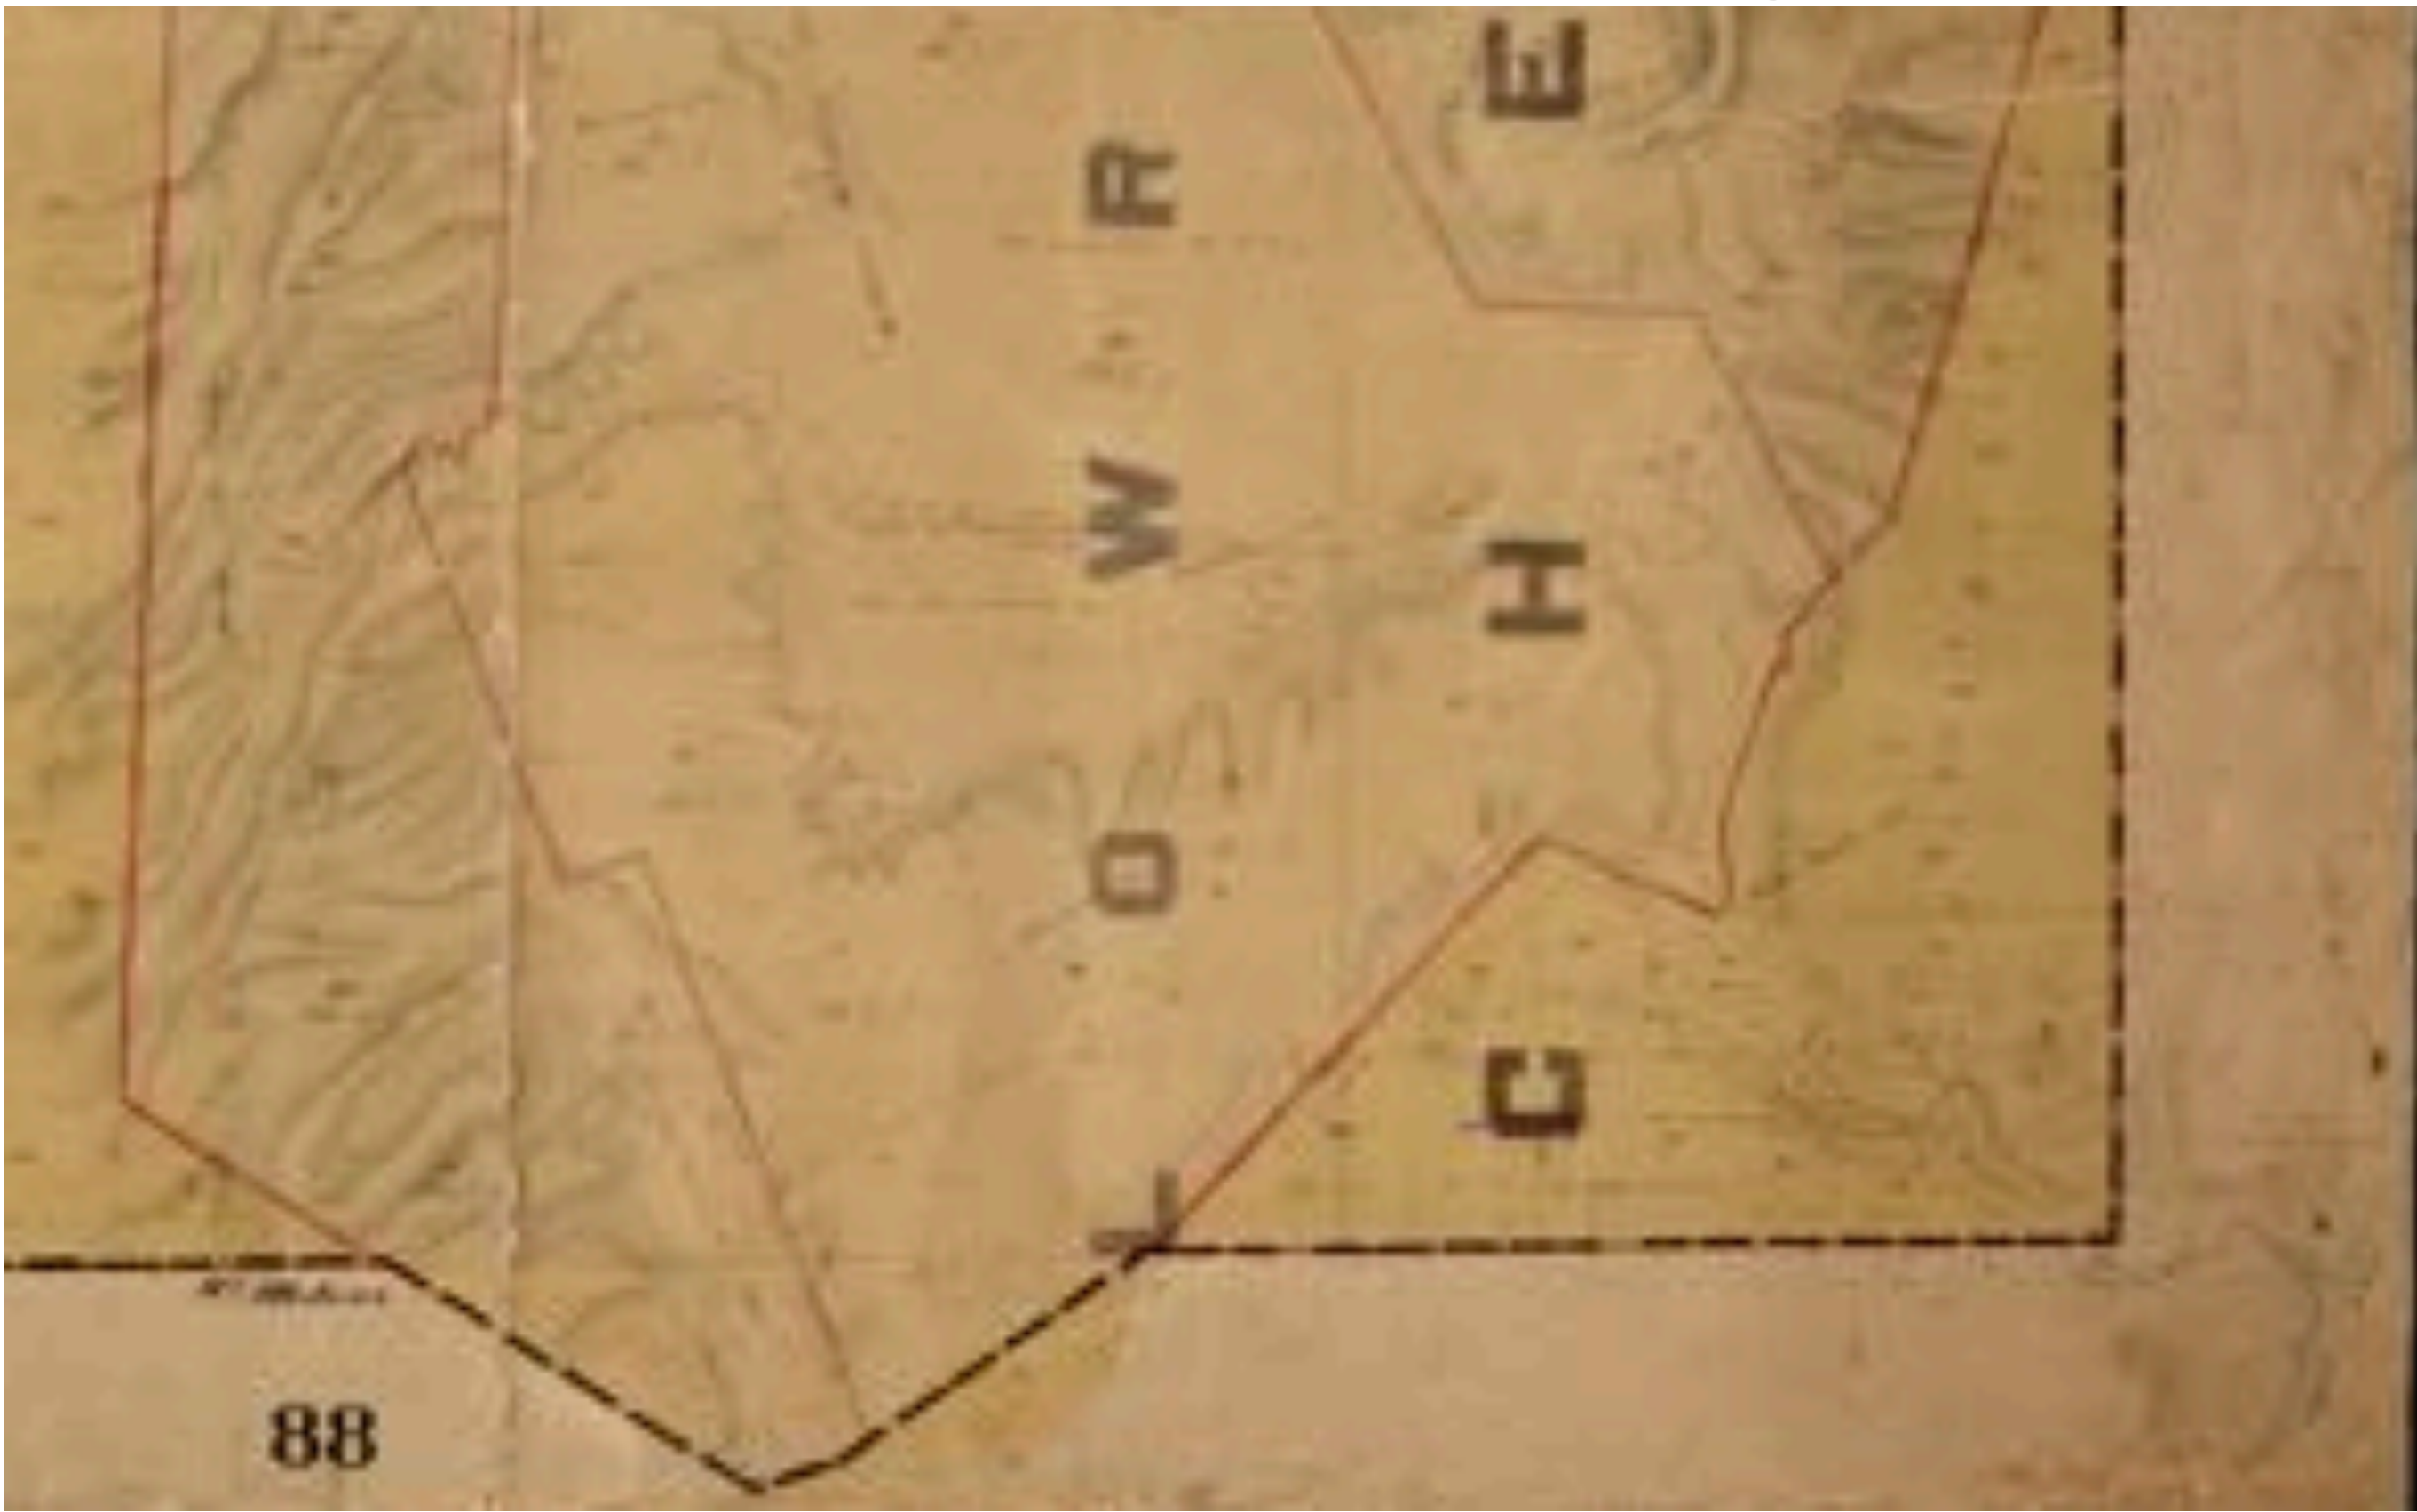
1870's Survey

- Using our two datasets of Survey map and DOC estimate, we have figures for wetland area of 5-15% of the catchment.
- Taking a figure of 7% as a reasonable estimate, this area of wetlands would have been sufficient to massively transform nutrients within the catchment. Their removal has effectively completely removed the ability of wetlands to treat nutrients within most of the catchment

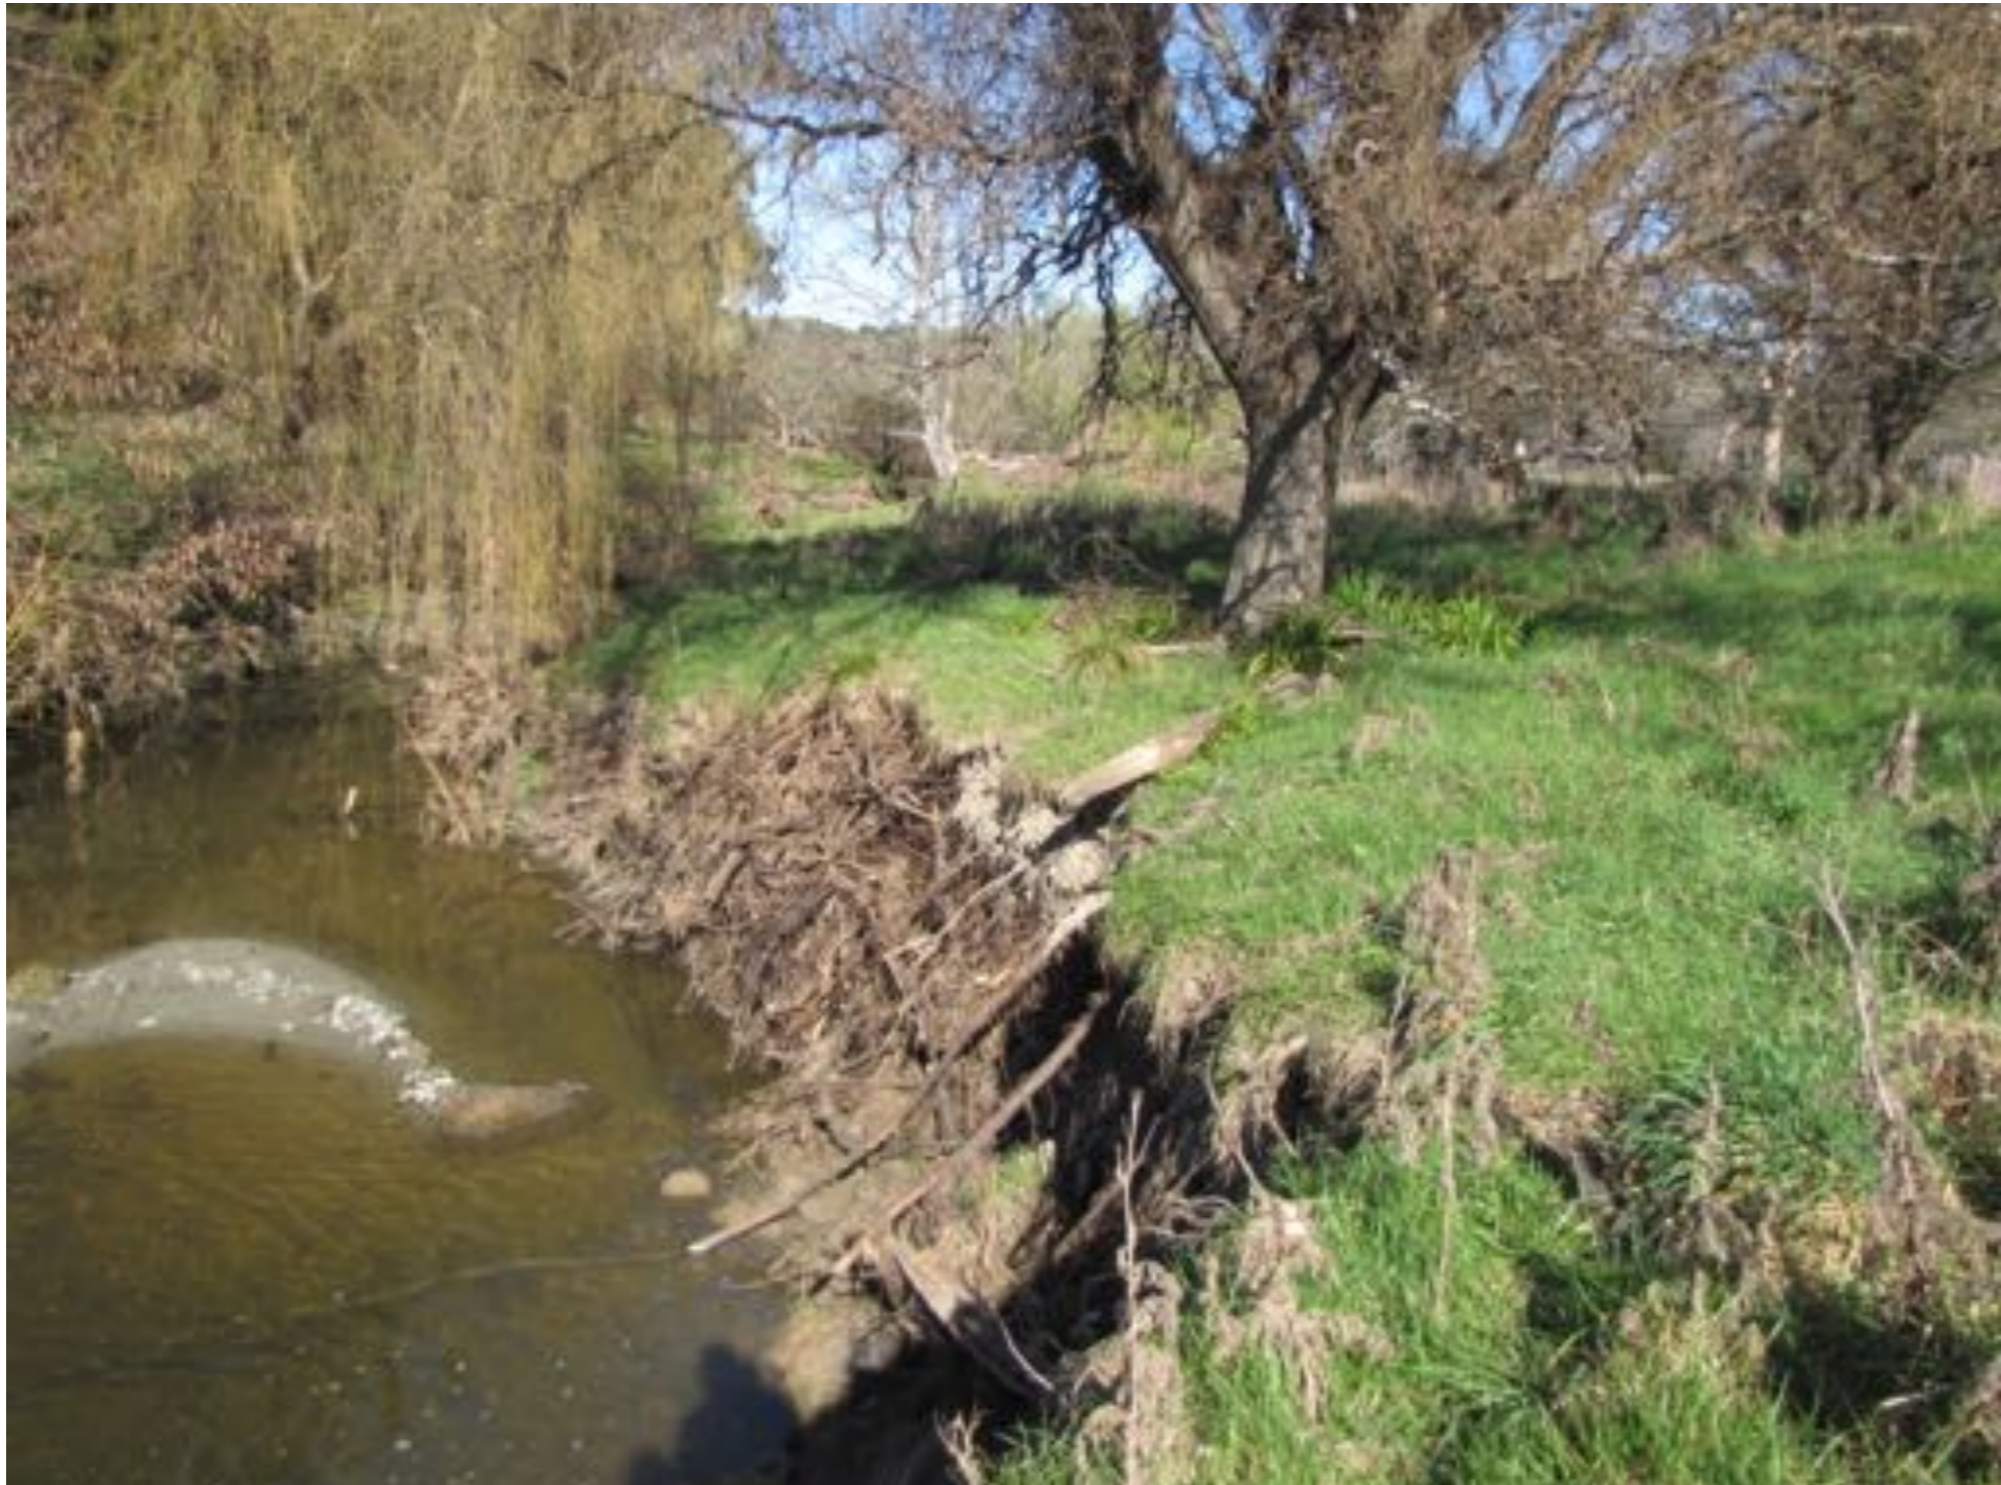
Many streams channelised, straightened, deepened, stripped of riparian vegetation, weed infested.

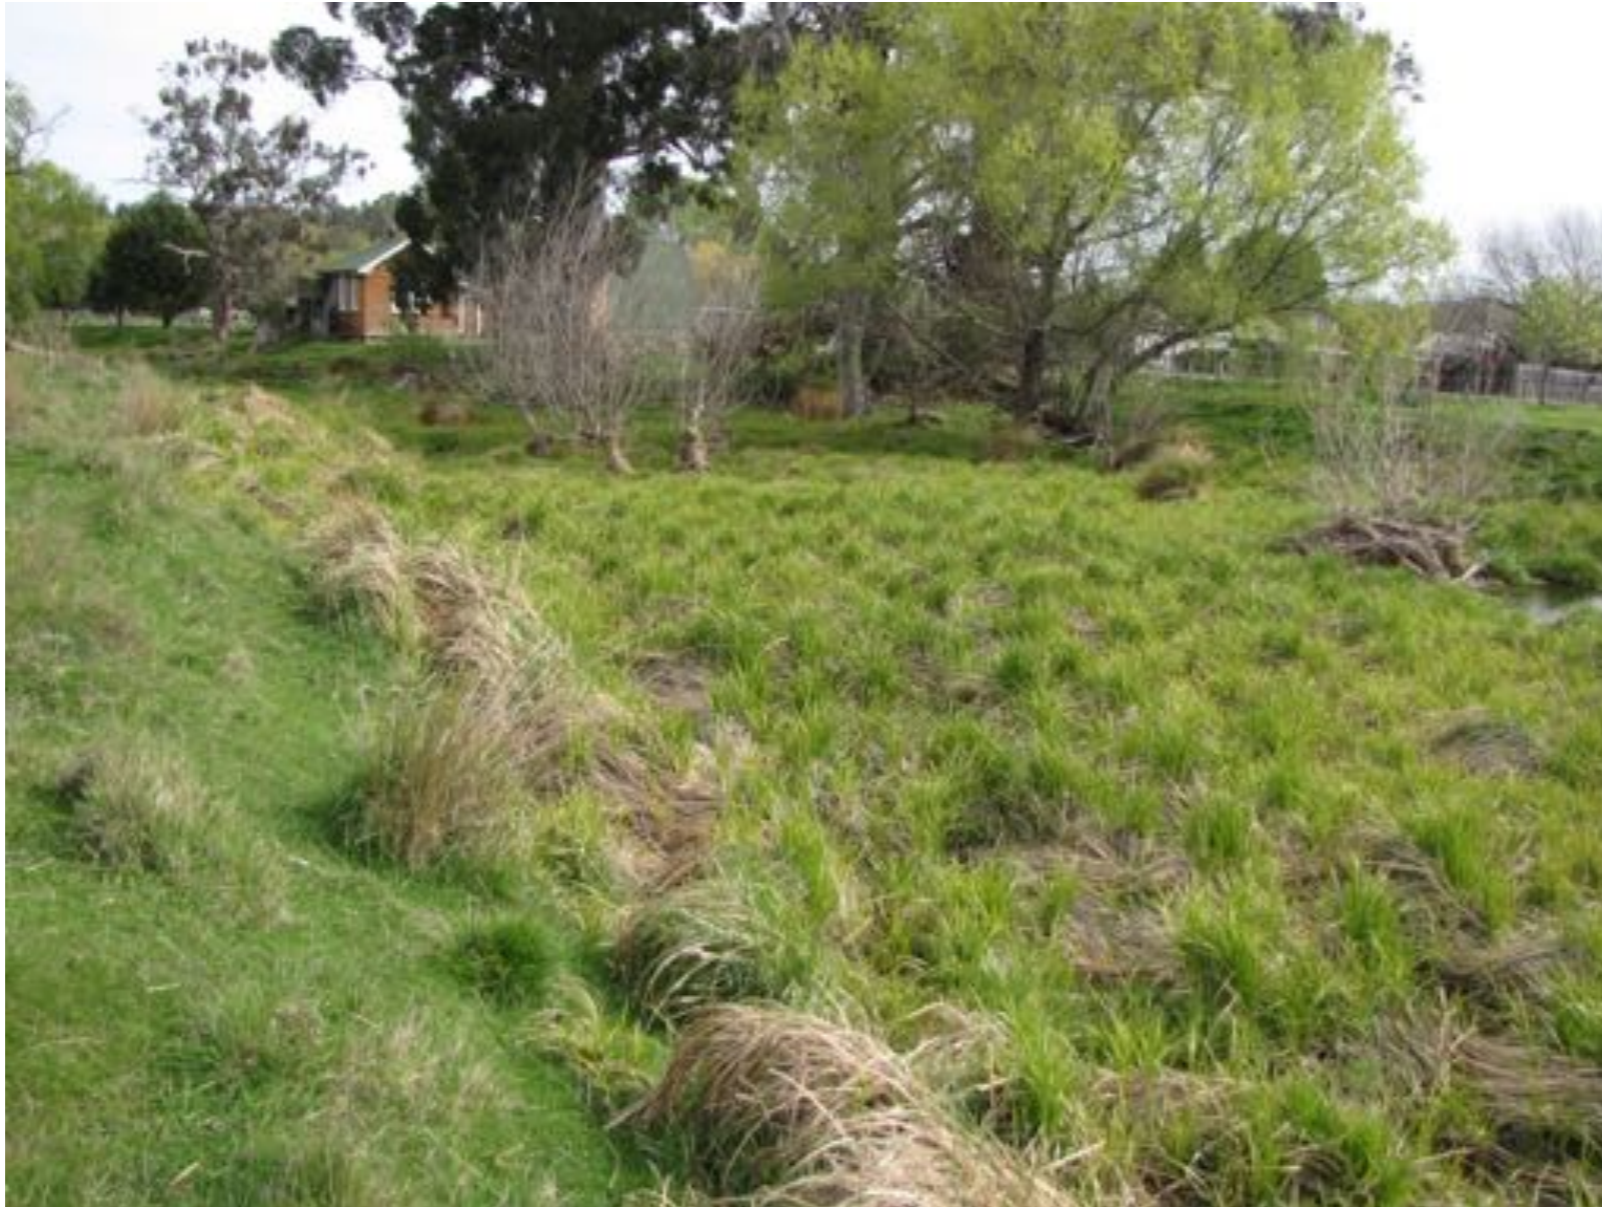
More natural stream bed

- **Wide floodway**
- **Dense vegetation**
- **Slows flows**
- **Provides habitats**
- **Facilitates natural ecosystem processes**

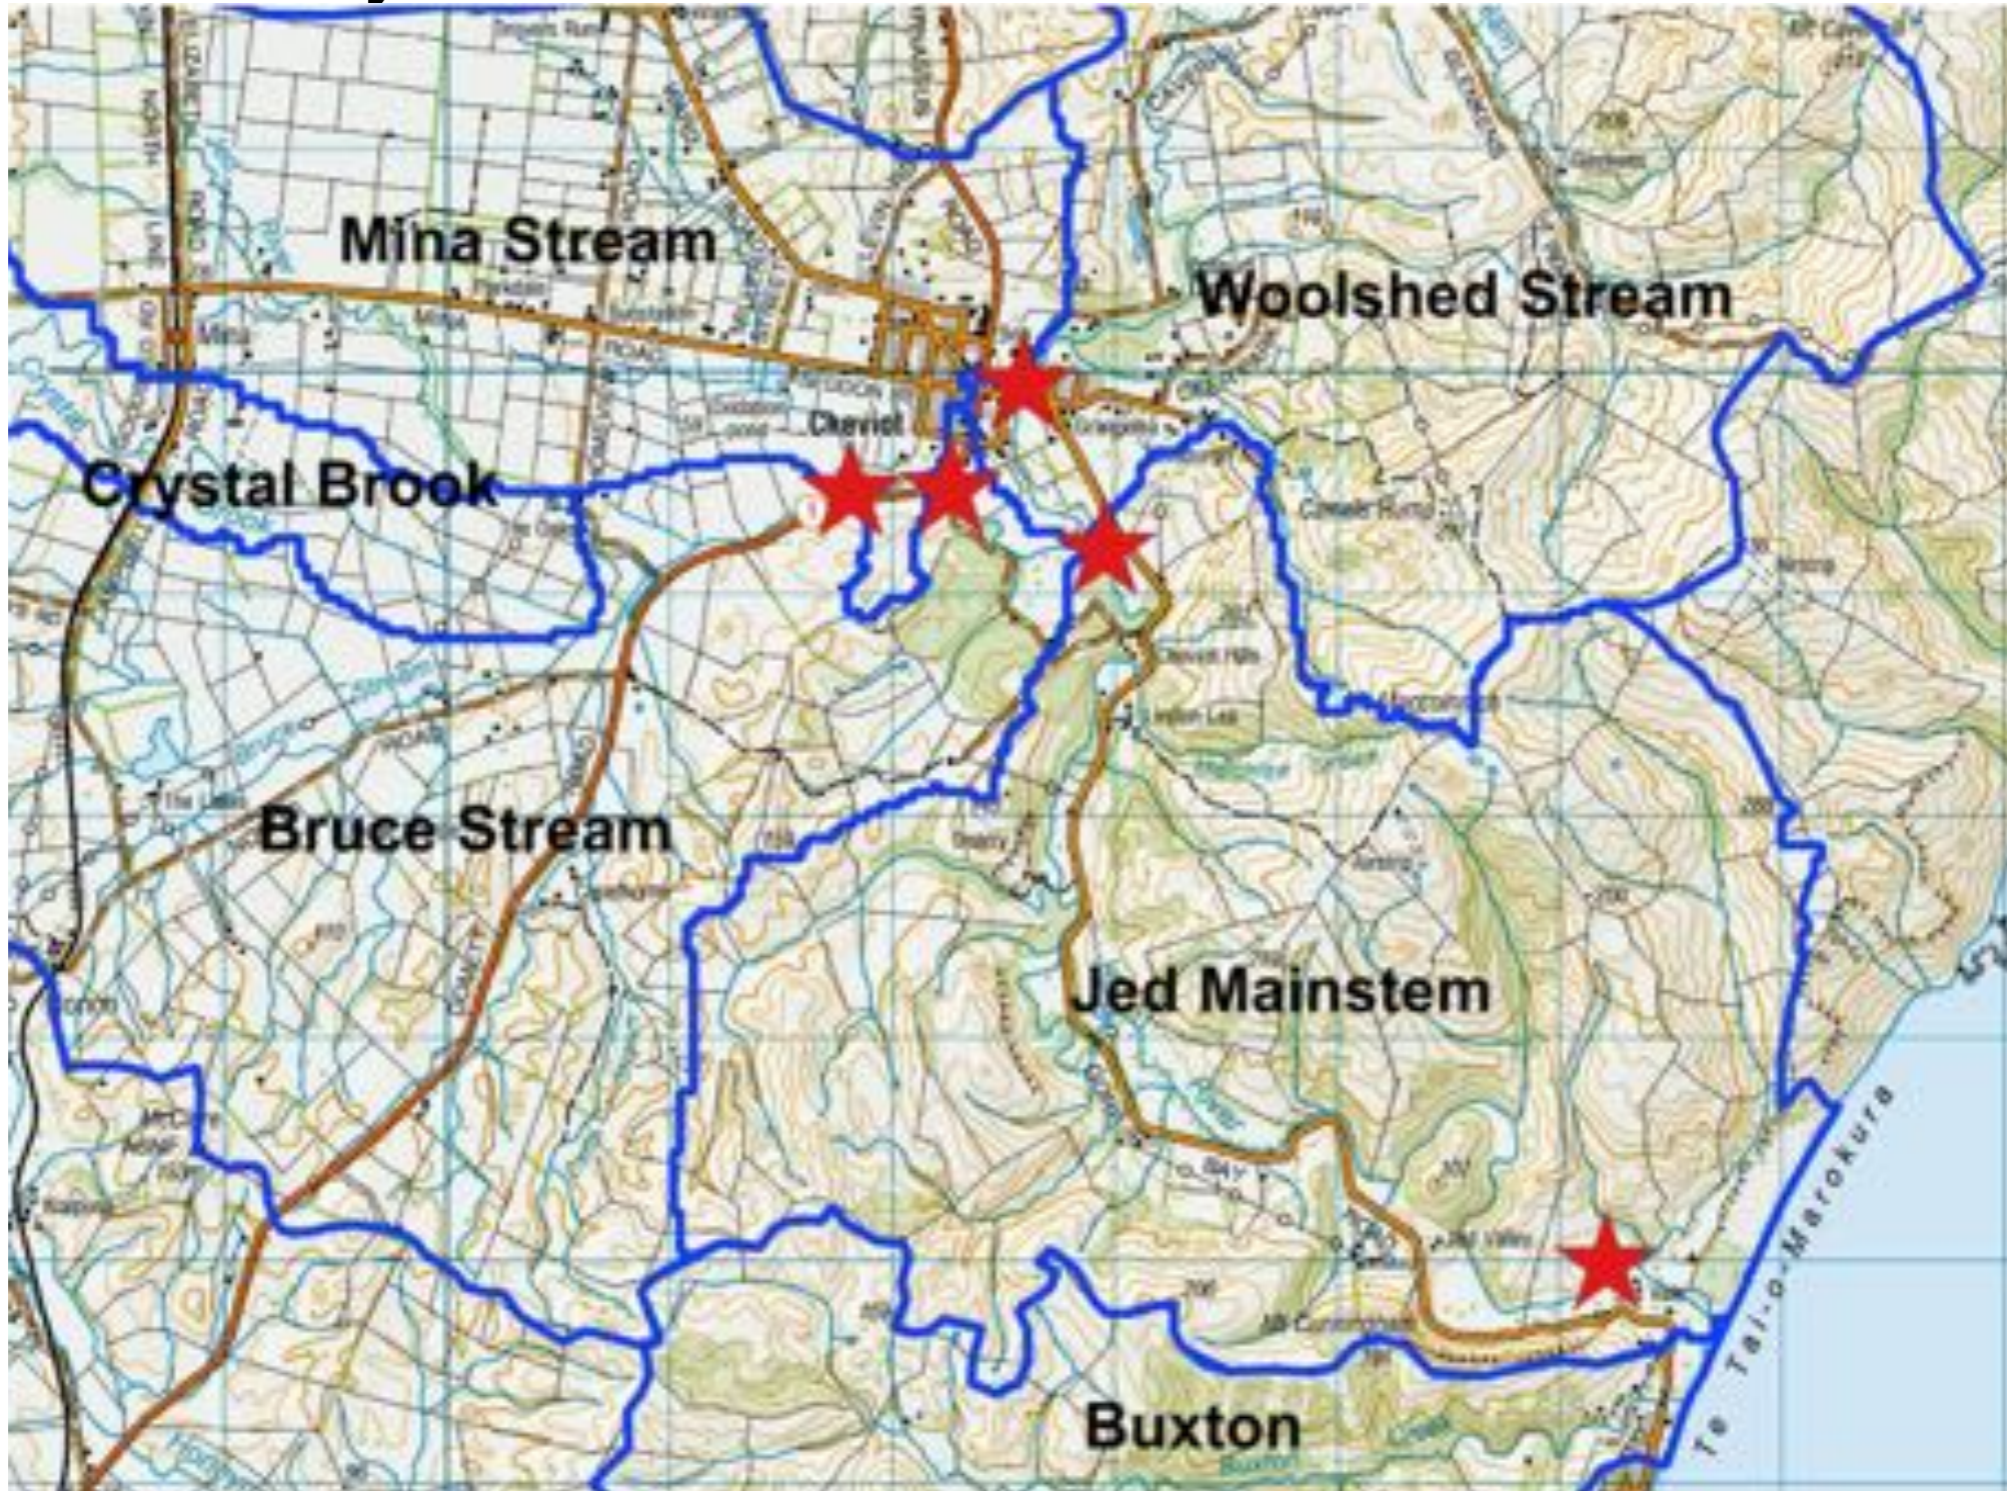
The only fully documented study is an ECan study over a full year in 2010/11

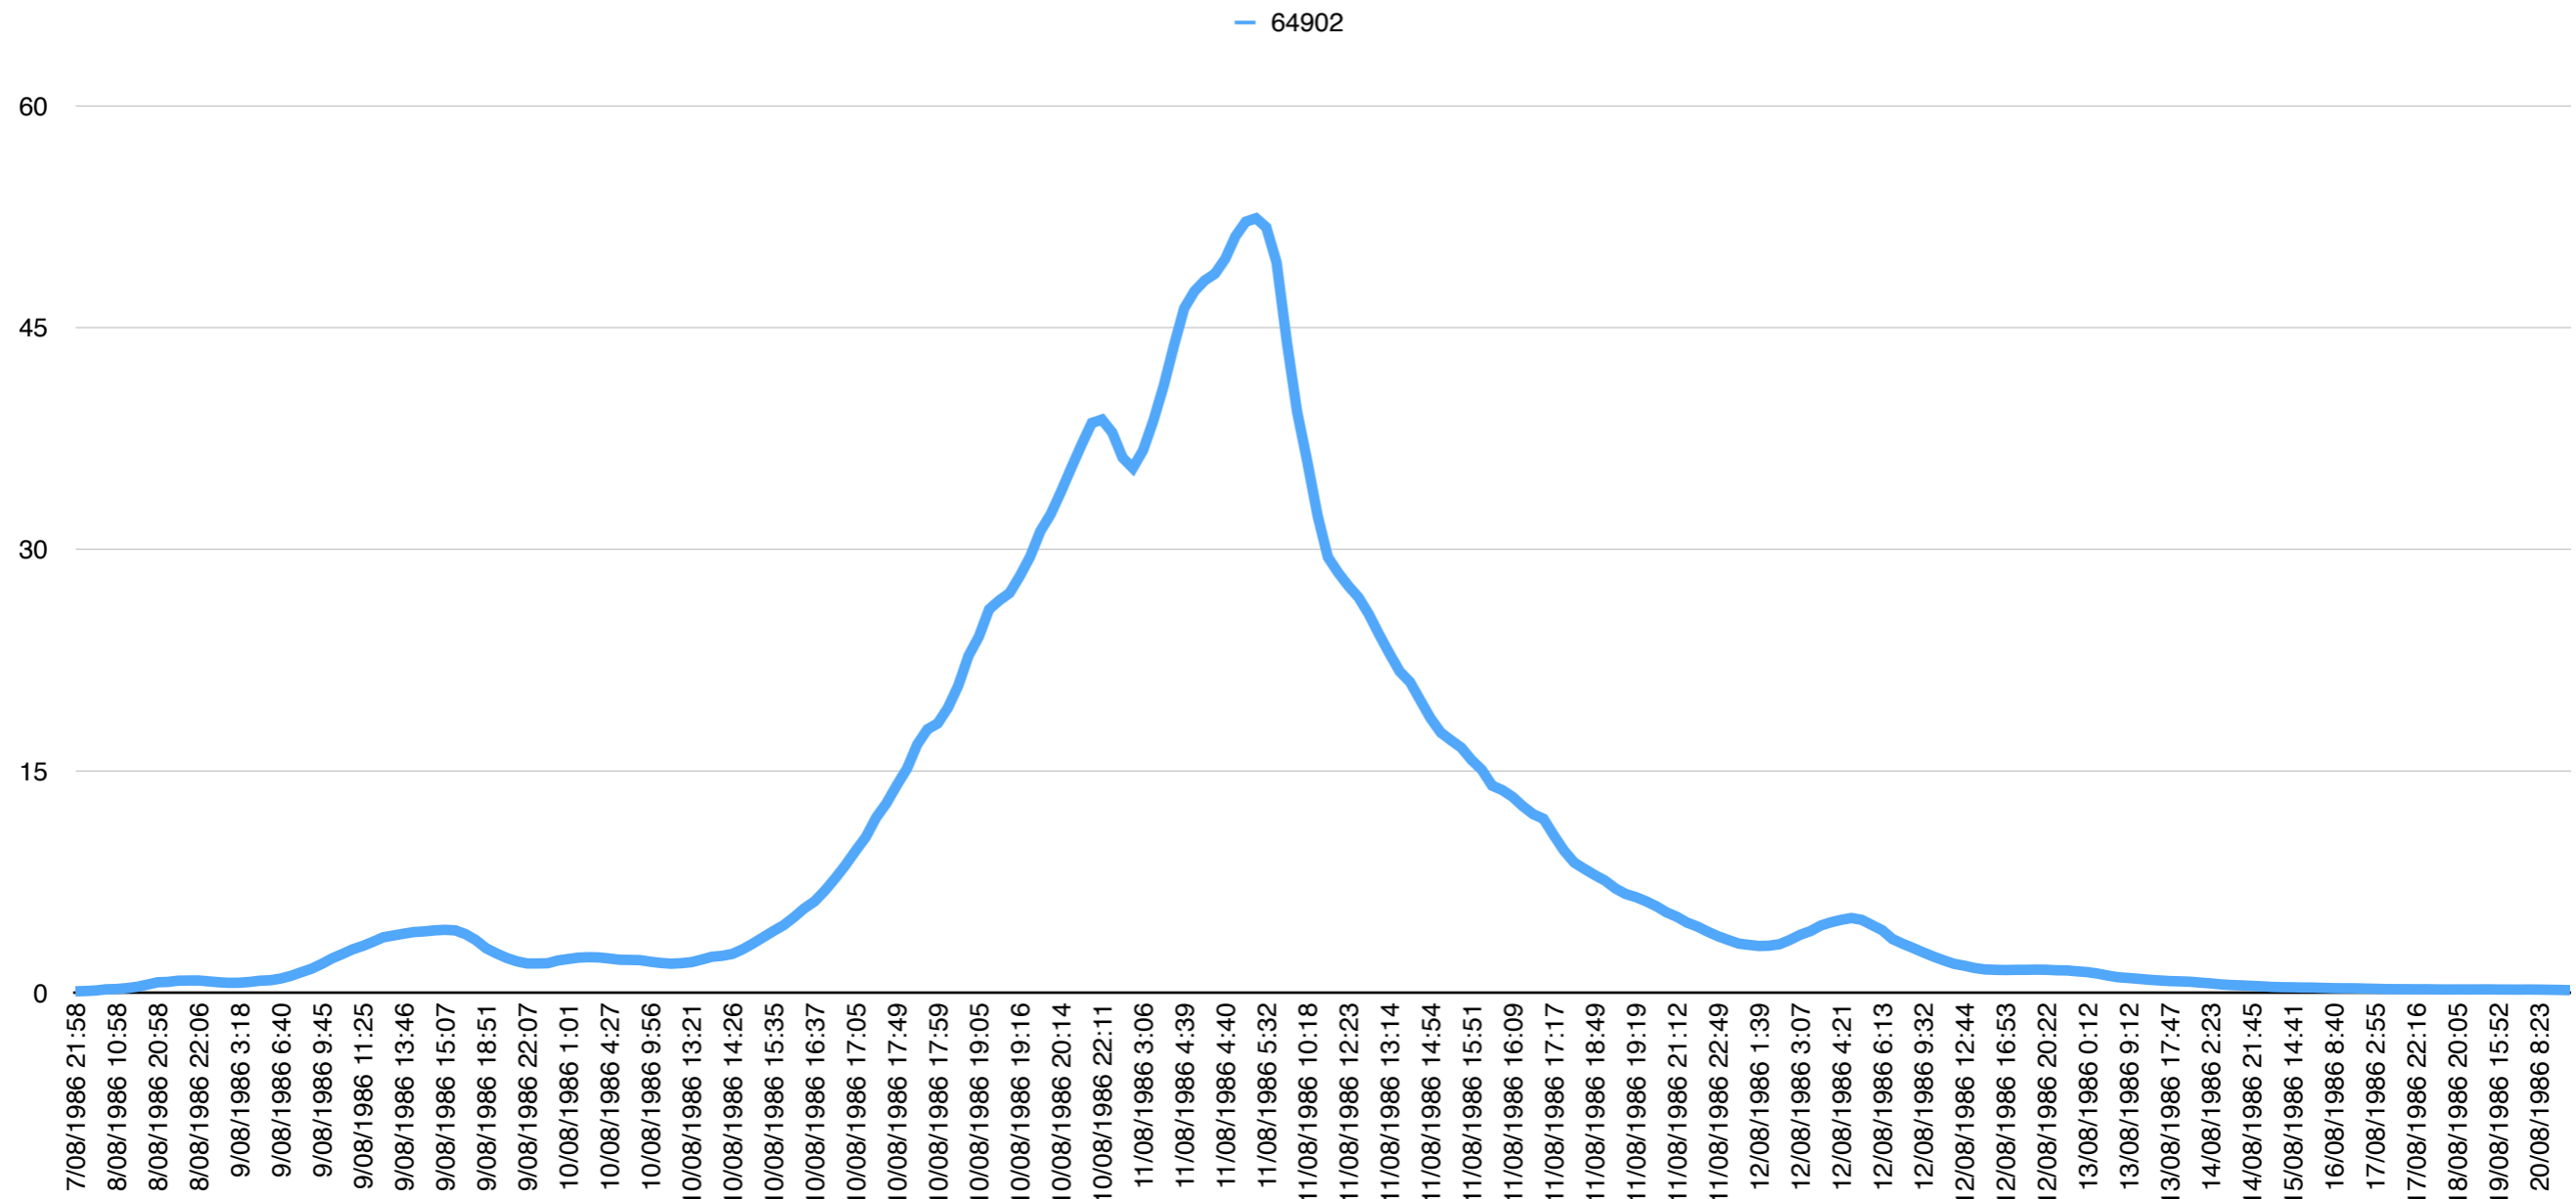
1986 Flood

1986 saw a 52 cumec flood (last year was 44 cumec). Graph shows flows over the rise & fall over less than 6 days
